# ATSPM Case Studies

MASITE Eastern Area Workshop – September 19, 2024

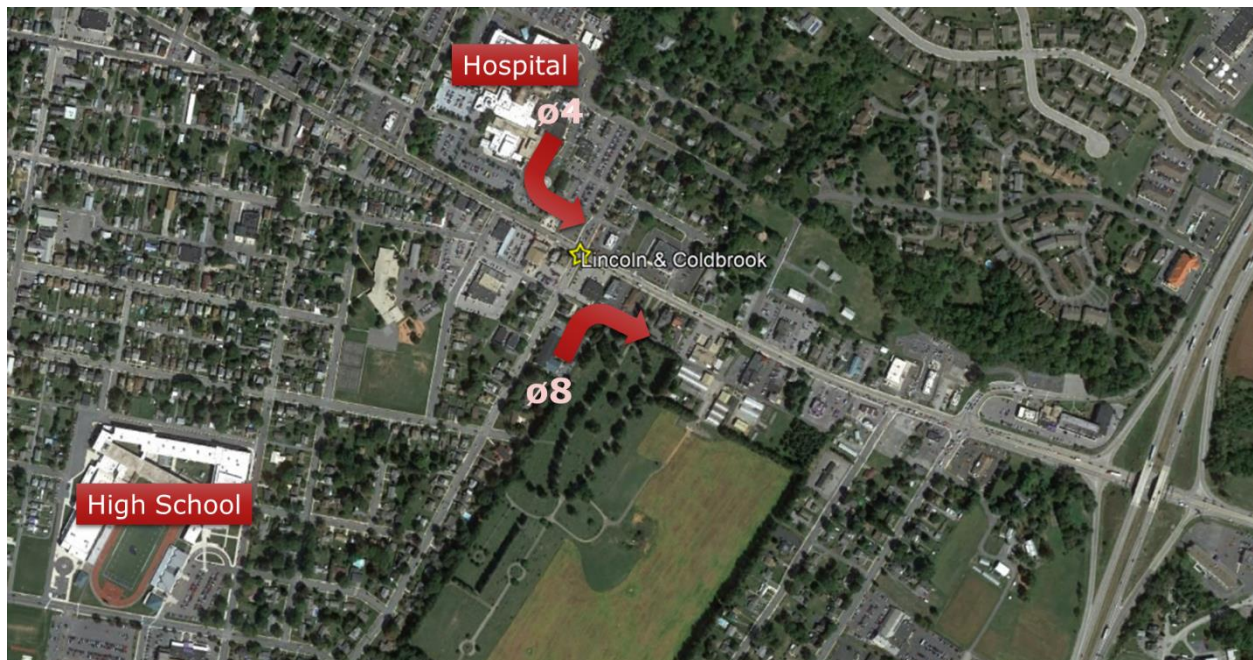
**Background:** A concern was raised by Chambersburg Hospital regarding left turns on the side street approaches at the intersection of Lincoln Way & Coldbrook Avenue in Chambersburg, PA, especially around hospital shift changes. The municipality suggested adding left turn phases to mitigate the concern.

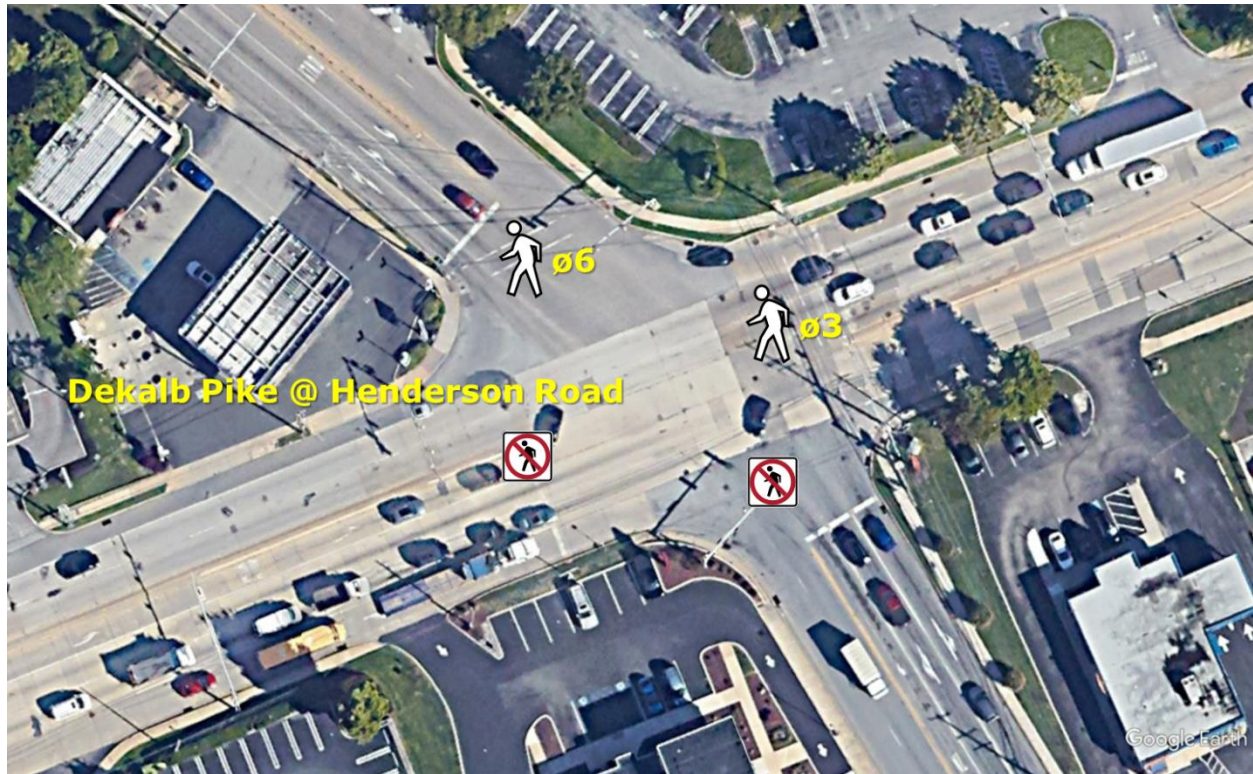
**Background:** If the split times at a traffic signal running a coordination timing plan are not long enough to accommodate the pedestrian walk and clearance times, a phase will go past the designated force off time and cause the coordinator to go into transition mode. The intersection of Dekalb Pike & Henderson Road has pedestrian crossings associated with phases 3 and 6, and is part of a coordinated system with 10 other intersections.

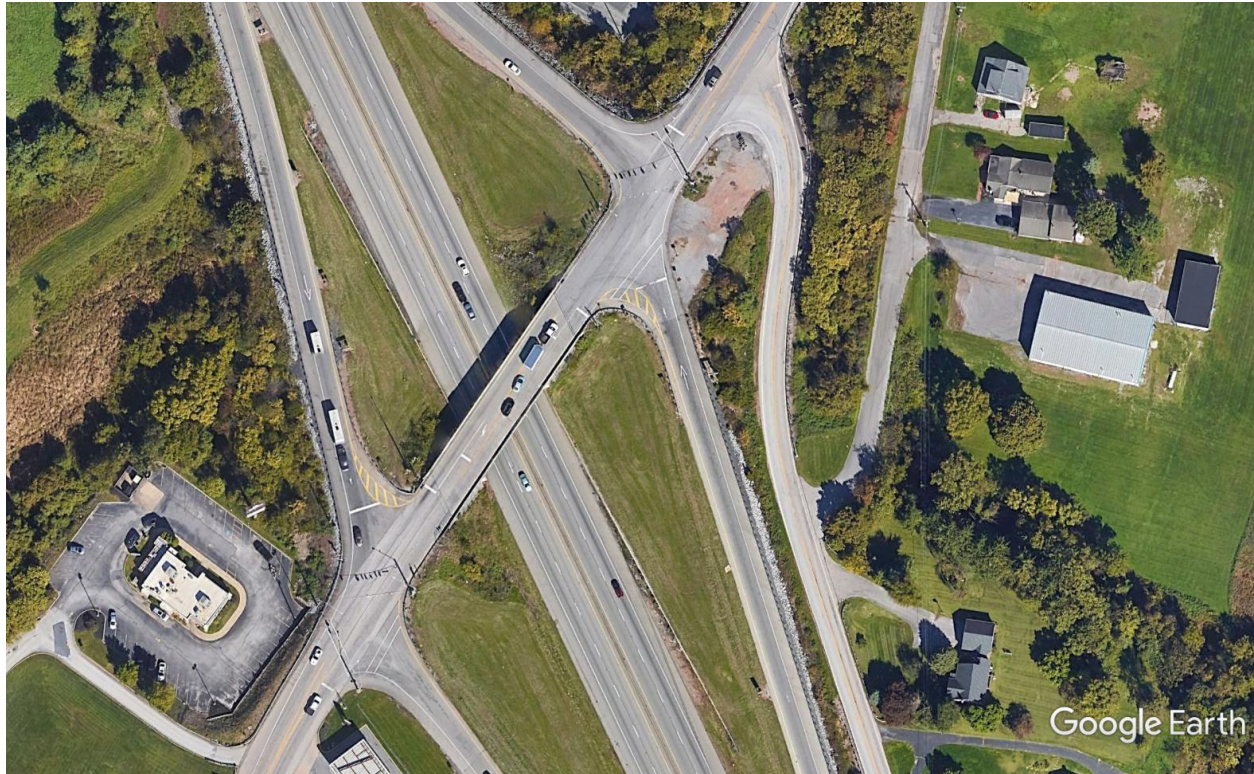
**Background:** Exit 28 from I-83 is a diamond interchange running on a single controller. The phasing is designed for both ramps to have green simultaneously if there is demand on both ramps.
